**MERRIMACK RIVER BASIN
WOLFEBORO, NEW HAMPSHIRE**

**CRESCENT LAKE DAM
NH 00309**

**PHASE I INSPECTION REPORT
NATIONAL DAM INSPECTION PROGRAM**

OCTOBER 1978

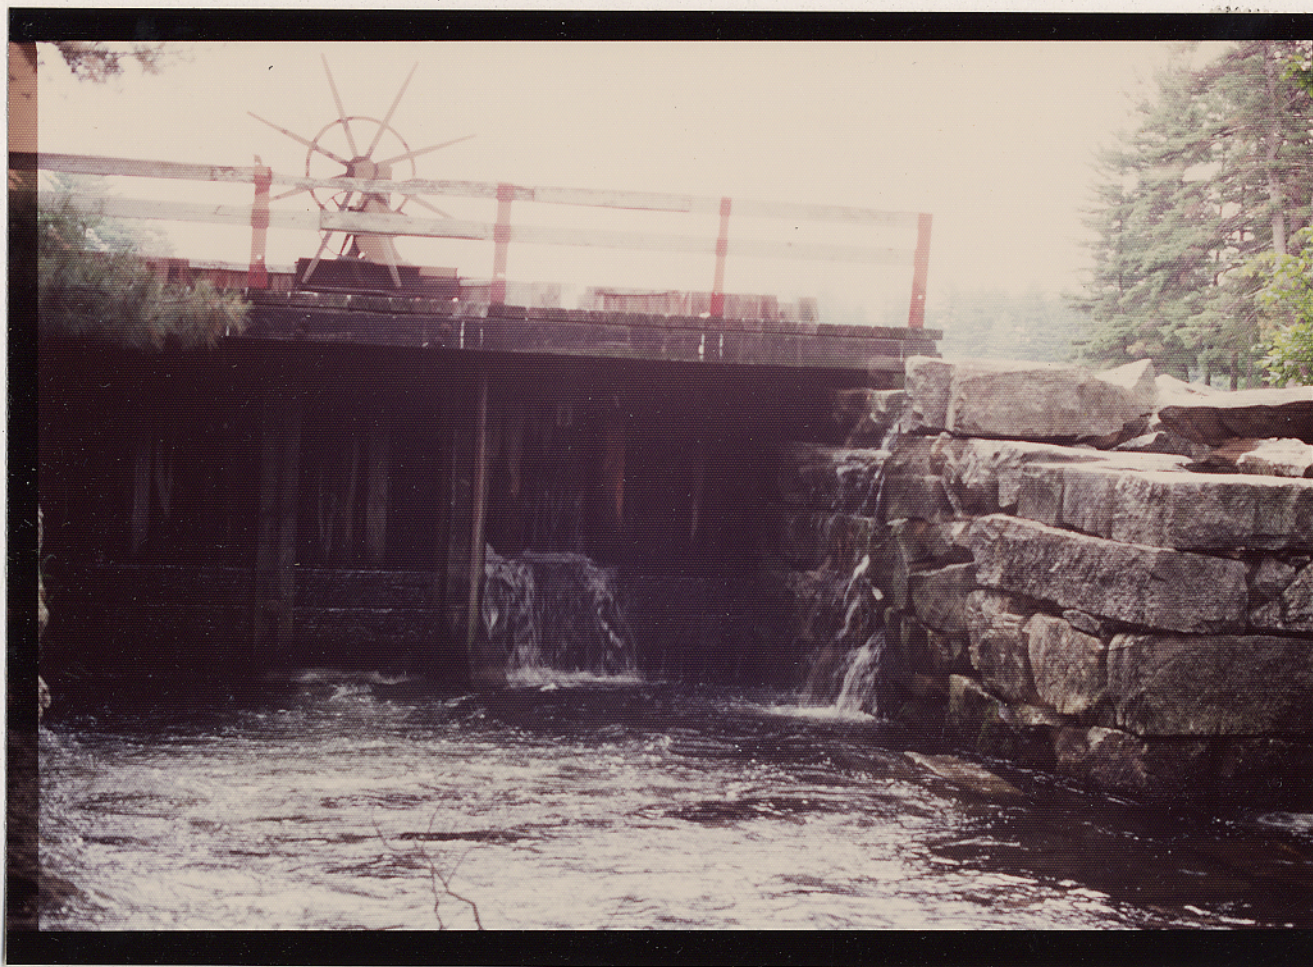
View of the dam from downstream showing timber section and its left masonry abutment. Note that some masonry blocks are missing from the abutment. The spillover section is to the right of the picture.

The missing masonry blocks from the timber dam section abutments constitute a weight reduction of the mass resisting the horizontal water thrust by gravity action, and should be restored for this consideration as well as hydraulic ones.

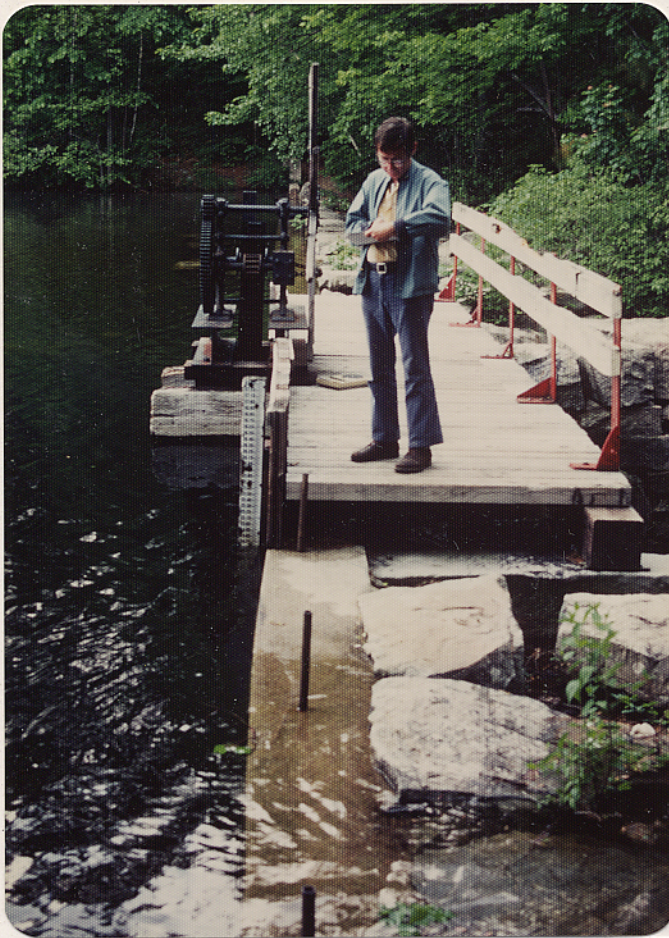
Photo 1 - View of dam from the right abutment looking along the axis of the dam. The short right spillover section is in the foreground, showing the original masonry gravity section and the upstream concrete facing wall. Flashpins visible in foreground are not in use. The walkway over the timber dam section and the low level outlet sluice gate hoist are visible in the background.

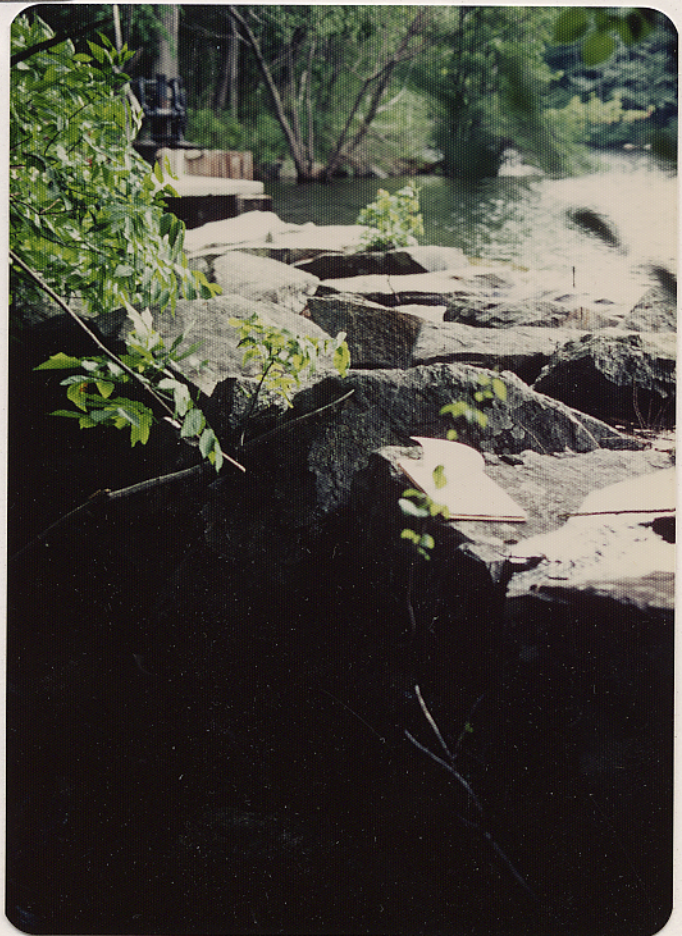
Photo 2 - View of the left spillover section from the downstream side. The upstream face of the spillover section has a concrete facing similar to the one shown on Photo 1.

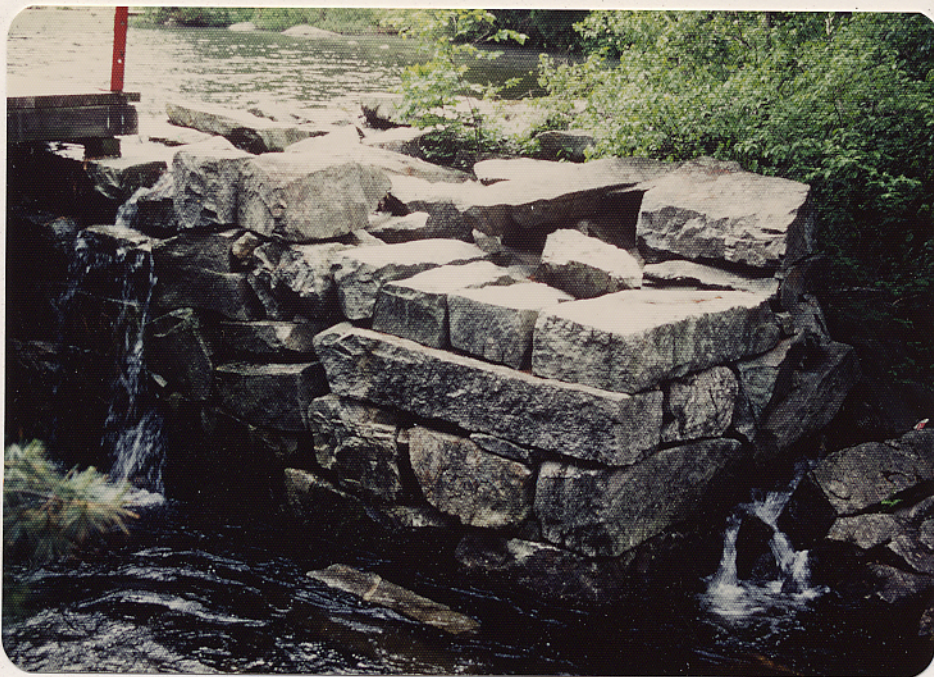
1. Large stone blocks pried loose from the top of the masonry abutments and dumped into the stream partly blocking the outlet channel and tending to reduce the stability of the abutment.
2. A reported leak in the left spillway area which could not be checked because of water flowing over the dam at the time of inspection.
3. The area downstream of the spillway on the left abutment is intensely wooded and could possibly block part of the spillway section during very large flow of the PMF magnitude.
4. The cast iron bearing cap of the gear shaft of the gate hoist is broken and has been replaced by a wooden block. This repair may fail at a critical time.

Photo 3 - View of the left masonry abutment of the timber dam from the right abutment. Note missing stones on the top course.

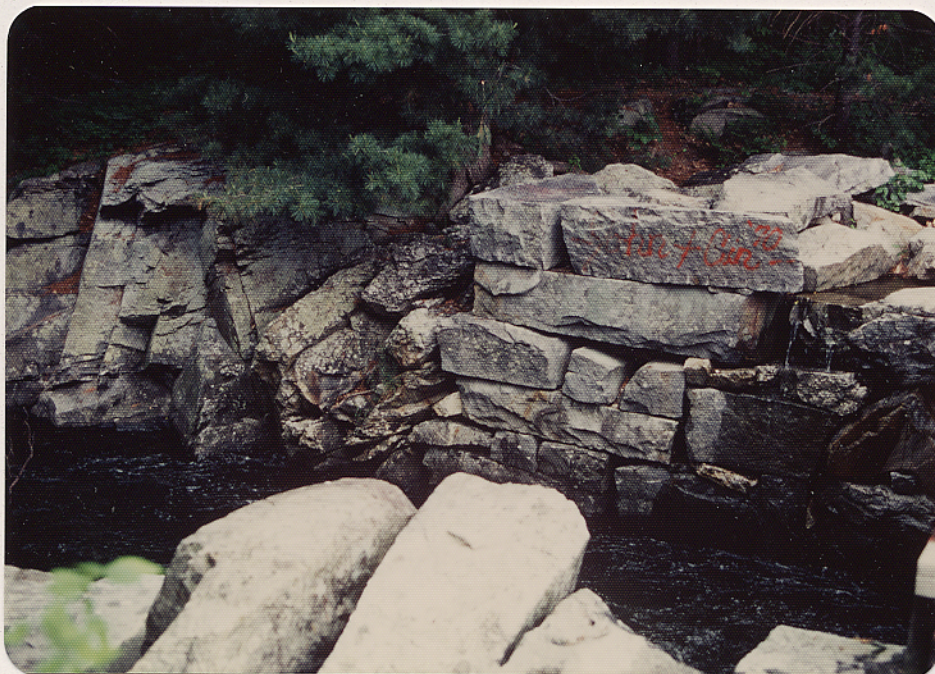
Photo 4 - View of the right masonry abutment of the timber dam.

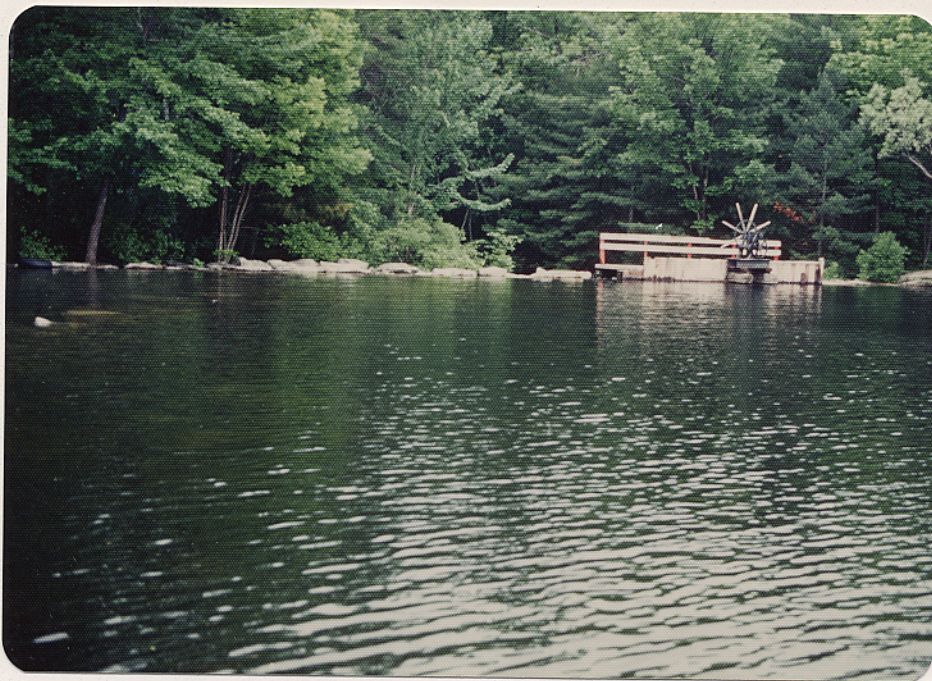
Photo 5 - View of the upstream face of the dam from the lake.
Note that the left spillover section of the dam is
obstructed by tree growth downstream of it.

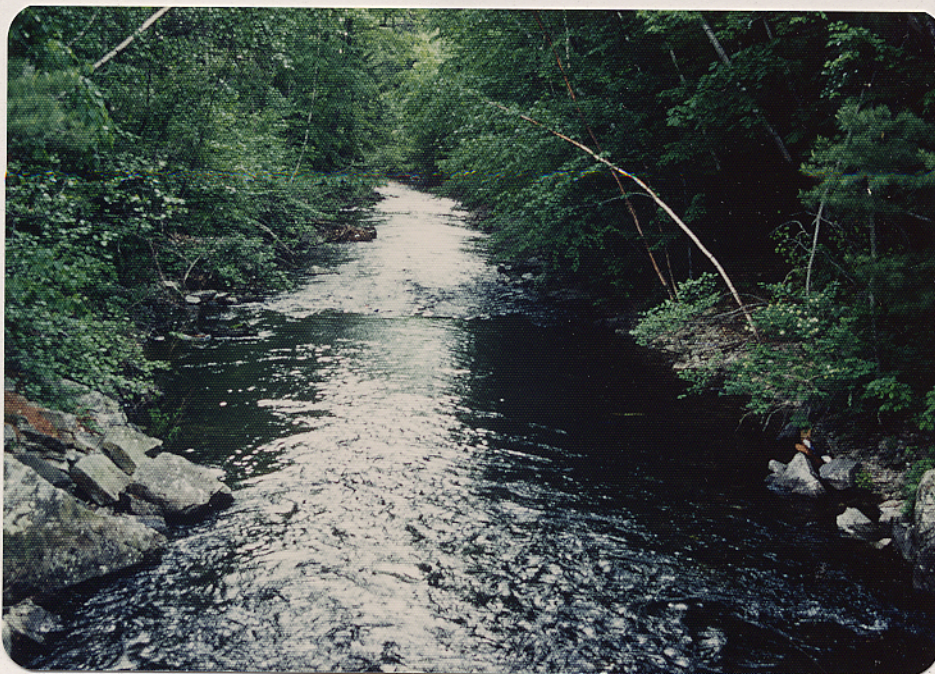
Photo 6 - View of the downstream channel of the Squam River.

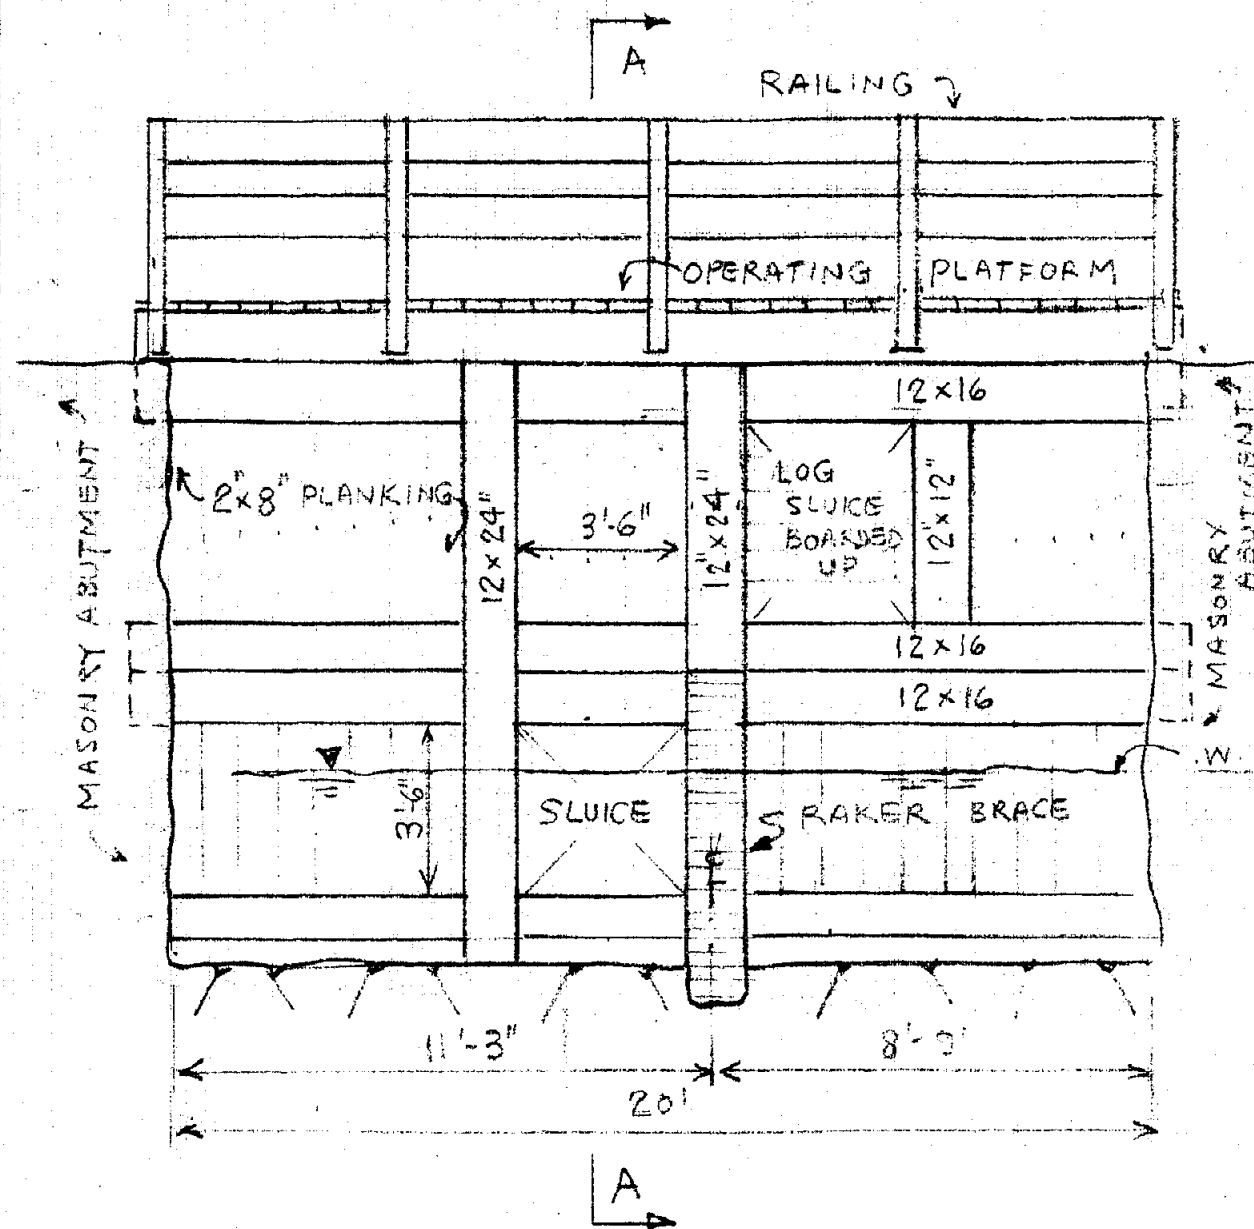
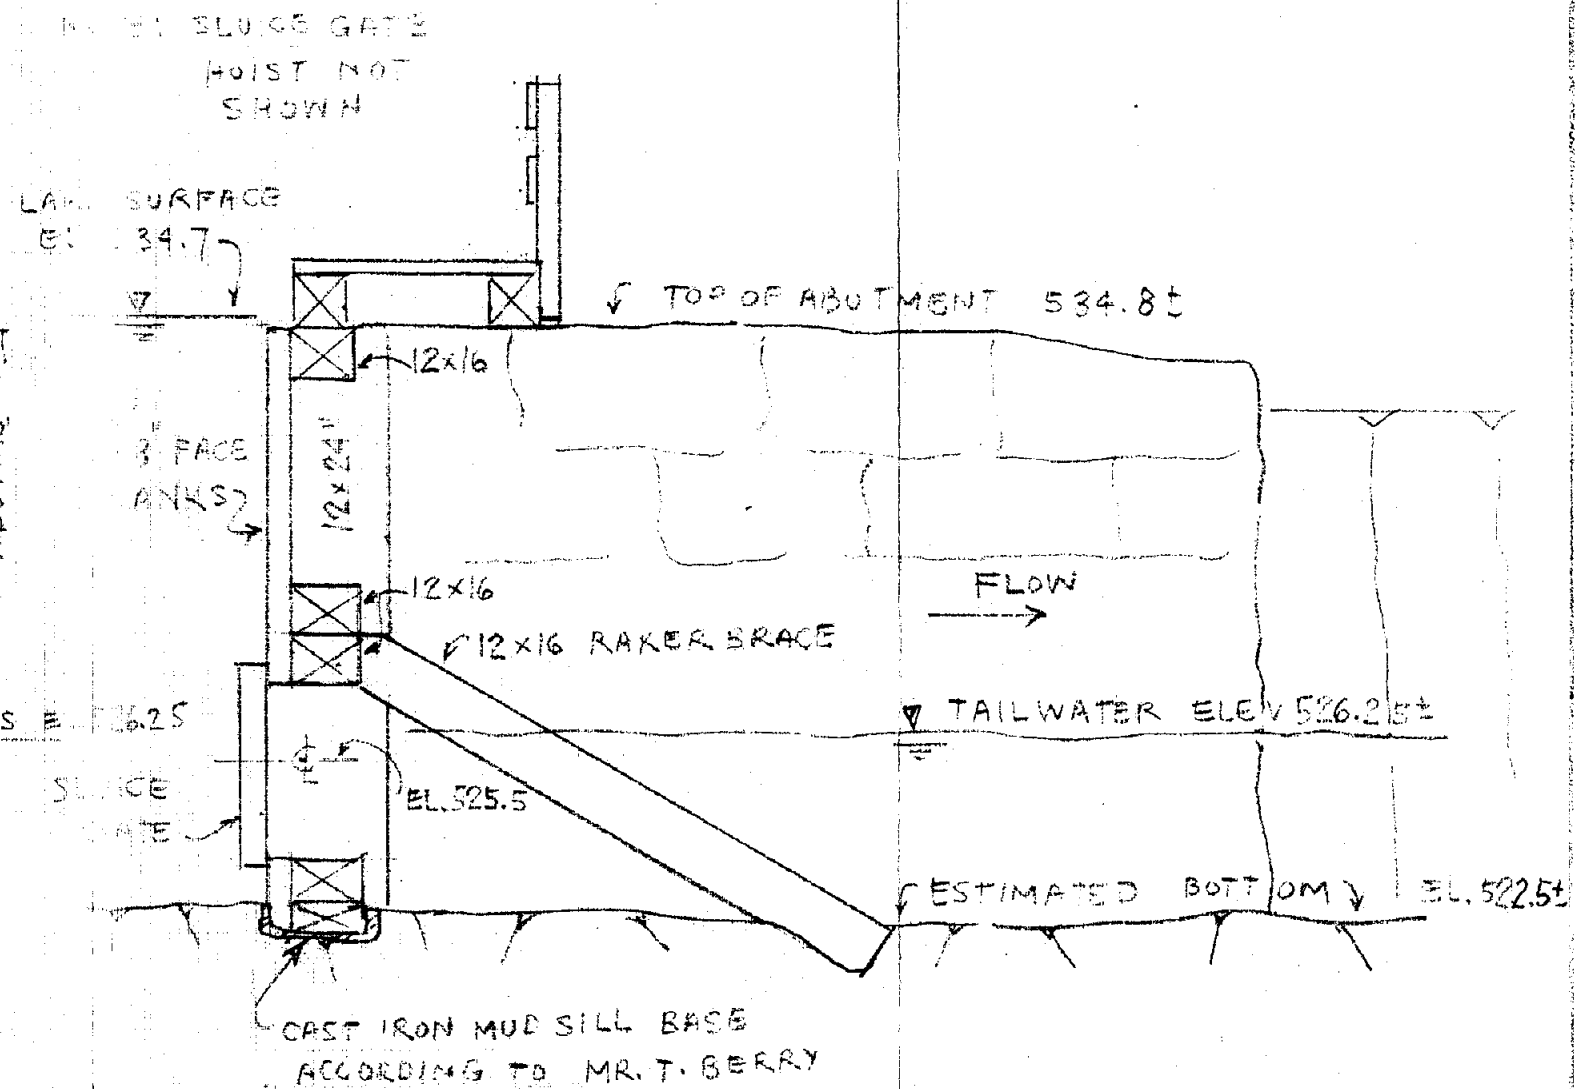
HARRIS-ECI ASSOCIATES		
CRESCENT LAKE DAM		DWG.
FIELD INSPECTION SKETCH		2

The timber dam section spans between the two massive masonry abutments described above. Details of the timber dam have been sketched during the field inspection and are reproduced in Drawing 2. The current timber section was rebuilt in the 1950's and utilized salvaged bridge timbers from an abandoned railroad line. The current arrangement of timber structural members is said to follow the previous design. All timbers appear to be in serviceable condition. A log sluice opening in the timber dam has been ineffectively sealed up and is leaking a considerable volume of water estimated at 50 gpm, (see Drawing 2).

The timber section of the dam has been framed as shown on Drawing 2. All dimensions are approximate. The framing at the sill is subject to revision since that part of the timber dam could not be seen and the conditions depicted in the sketch are the inspection team's interpretation of conditions described by Mr. Thaddeus Berry, the person in charge of the operation of the dam. If the timber framing does in fact correspond to what is shown on the sketch, then the stresses in the 2 by 8 in. timber plank dam face should be investigated for overstress at normal and PMF lake levels.

Stresses in the members of the timber dam section should be computed using a properly dimensioned framing plan of the structure. The plan should contain information on the framing at the bottom sill which was not visible under tailwater during the inspection. The stresses should be computed for loading cases where the water level is at the top of the spillover section and also for the SDF condition. The stresses in the timber face planking are believed to be especially in need of assessment.
